ERM Safety Alert – Air Line from Compressor Detachment

Event: Air Line from Compressor Detachment
Activity: Using Air Rotary Drilling During An ESA
Location: Queensland, Australia
Date: April 2010

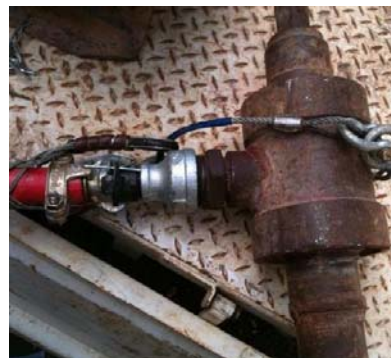
Correct method for attaching hose at rig end.

- *The subcontractor crew knowingly took short cuts and didn't follow their procedures;*
- *During Tool Box talks, reinforce importance of using Whip Checks and safety pins;*
- *Foster a culture with subcontractors whereby intervention is promoted; and*
- *Update our JSAs to reflect that when working with compressed air, measures are to be taken to ensure that Whip Checks and safety pins are secured.*

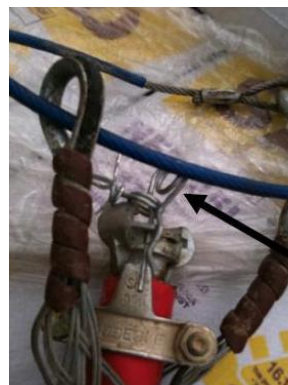
Split pins (Safety Pins) shown here should have been in place as an additional safety mechanism on all hoses with such fittings.
